OPTION 456 - RETROFIT PROCEDURE

To retrofit SA456 to the vehicle:

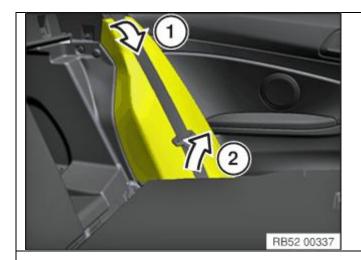
Unfasten the rear safety backrest and tilt it forwards. Pull the safety belt towards the middle and place it over the head restraint.

Pull the top backrest side section (1) forwards and pull it out upwards (2).

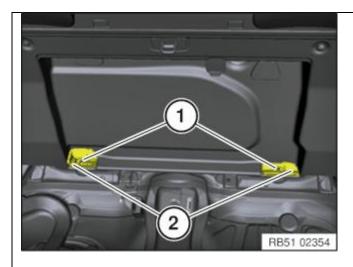
Remove the screws (1).

Remove both left and right wind deflector brackets (2).

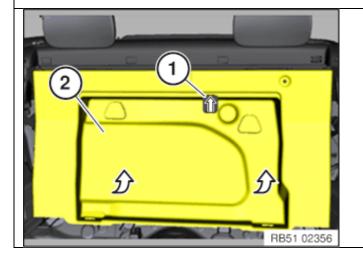
Slide the locking slide for the wind deflector (1) upwards.

Feed out the trim panel (2) and remove.

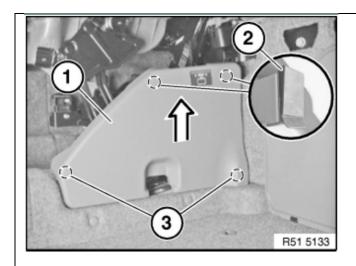
Slide up the trim for the main bearing on both left and right sides of the luggage compartment.

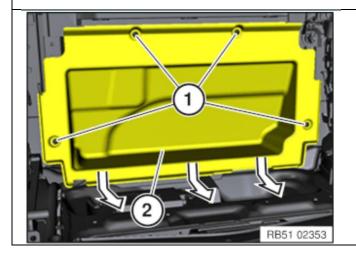
Remove the four plastic rivets (1) from the luggage compartment partition wall. Remove the partition wall.

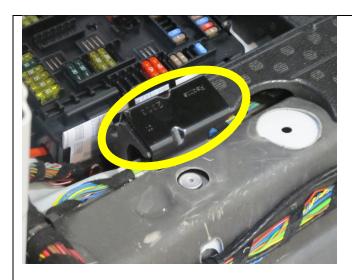
Install P/N 51 47 7 363 430 (bracket for the "thief-proofing flap") using two blind rivets (P/N 07 14 7 265 872).

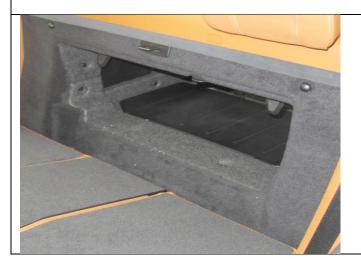
Reinstall the removed parts in the reverse order of their removal.

Use the parts list below as a guide.

The partition flap is installed last. Push the door down into the metal brackets.
